**Leicestershire and Rutland Gardens Trust
Walled Kitchen Garden Register**

Name of House:	Stapleford Park			
Address:	Stapleford, Nr. Melton Mowbray Leicestershire LE14 2EF			
Ownership:	Private	Public	Institutional	Other: x Commercial
Grid reference:	SK810181	Map No: Landranger Map No: 247		
Date original WKG created:	C 1670 (according to the EH Register of Historic Parks and Gardens). However, the bricks of the garden walls are 9" x 2", so could be a little later: late 17 th /early 18 th century.			
Other key dates in development:				
C 1849	Gardener's cottage built (according to EH listing). This date is over the archway in the adjoining wall			
1894	After 484 years of ownership by the Sherard family (who became Earls of Harborough), the estate was purchased by the Grettons and remained in their ownership till 1985.			
1987	Restoration work was carried out by the garden designer, Bunny Guinness on the walled kitchen garden, including repointing walls, repairing cast iron entrance gates, building pergolas, trellis work and seats. Box hedges were planted.

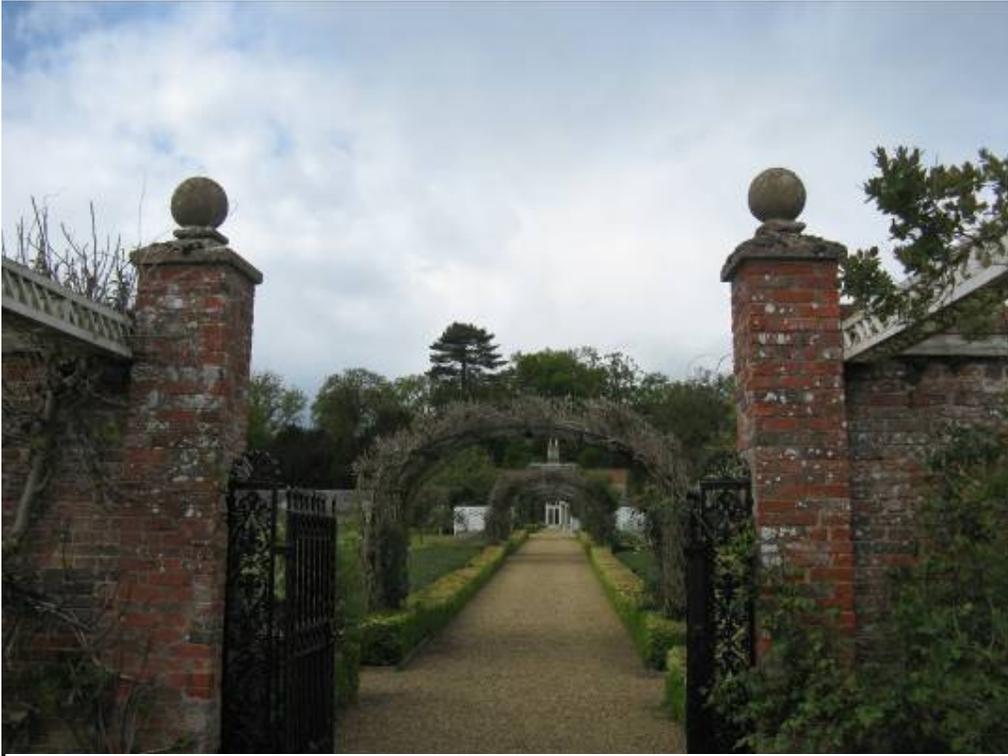
Above: looking north through main entrance into the garden

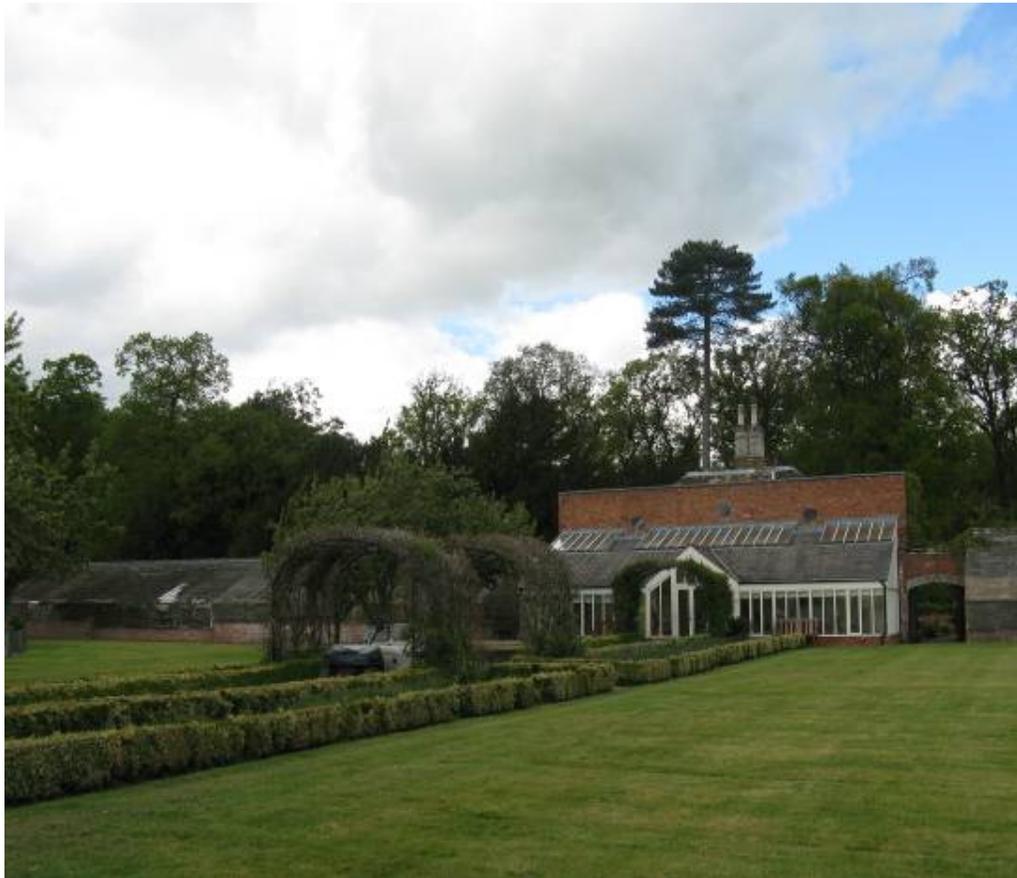
Below: View of garden, looking north. The conservatory in the centre is modern.

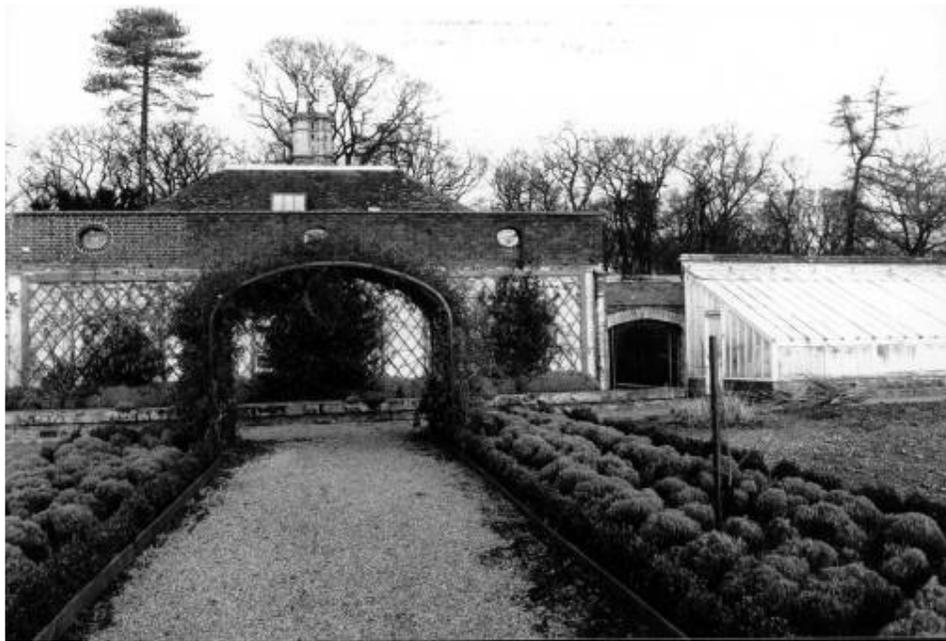
Above: view of north of garden – December 1992 Shows right-hand greenhouse and gardener's cottage behind wall.
© Historic Environment Record

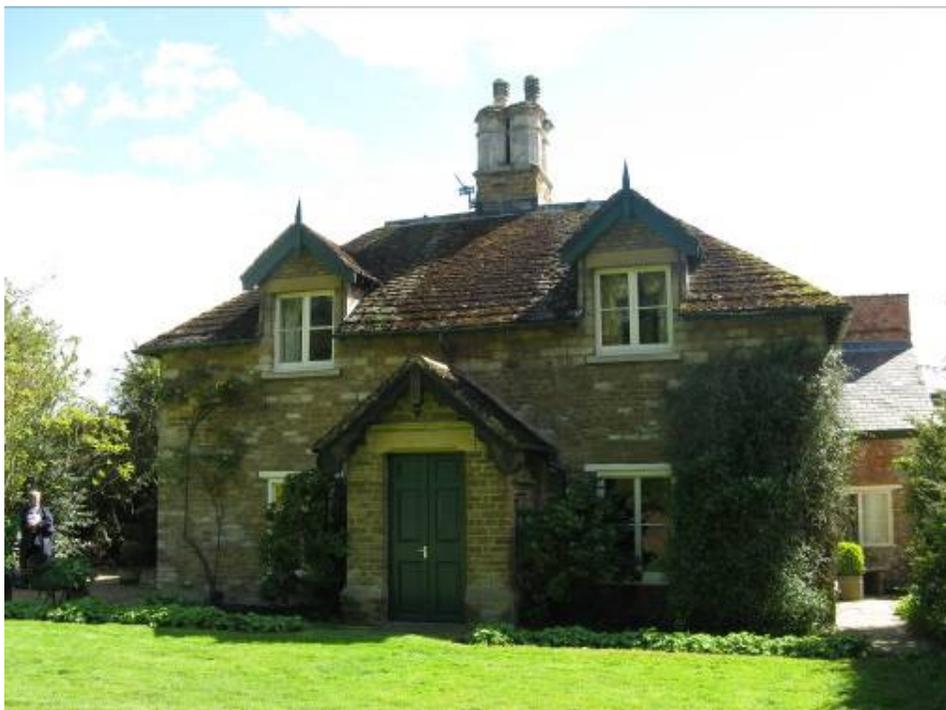
Below: Gardener's Cottage

Gardener’s house, cottages, bothies	<p>Yes. The gardener’s house is listed: late 18th century and 1849, restored 1987. See EH listing for full description.</p> <p>No evidence of any bothies.</p>
Wells, ponds, tanks, towers	1884 map shows two pumps – one inside the garden and one near the back sheds. None are now visible.
Planting	<p>The 1884 OS map showed the garden divided into a grid of 8 compartments with (fruit?) trees positioned along the outside paths at regular intervals. By 1930, the layout had been simplified with one main path running north to south down the middle and a cross path east to west (i.e. the existing layout).</p> <p>The current planting is ornamental, including a central pergola with a wisteria. There are some original fruit trees.</p>
Other key features	According to OS maps, there was a sundial in the garden in the centre of the garden. This no longer exists.
Any other information:	<p>In June 1983, a Feasibility Report was prepared for Melton Borough Council to investigate the possibility of using Stapleford Park as a Museum of the Countryside. The walled kitchen garden was to be used as a nursery and shop:</p> <p>“the establishment of a garden showing the history of the introduction of new plants and the resulting richness of the kitchen garden and orchard in the 19th century. There would be</p>

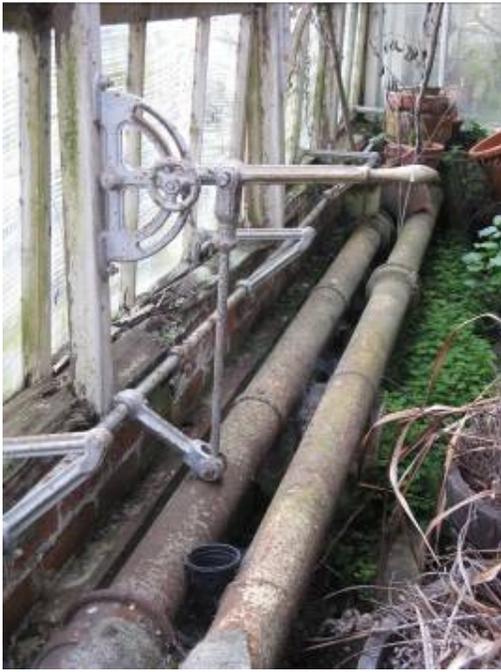
Left: Pipework and window-opening mechanism in right-hand glasshouse
Right: Manufacturer's name plate on door latch reads:
"Foster & Pearson Ltd. Beeston Notts"

The 1884 OS map showed a single greenhouse on the south side of the north wall (on the east side of the garden). There was also a small greenhouse, positioned centrally on the south side of the north wall (where the modern conservatory for the gardener’s house now stands). The order placed with Thos. Messengers for a boiler (see below) refers to a “Muscat Vinery and 3 peach houses”, so this would presumably be the existing greenhouse, which has heating pipes. There are Foster and Pearson name plates on the door.

<p>The current condition of the greenhouses is poor. The ironwork for opening front and roof lights remains, but there is no sign of any staging, grates for under floor heating (etc).</p> <p>The current owners anticipate renovation of the glasshouses in the near future.</p>
Frames	No frames are visible now, but the 1884 OS map shows possible frames in an area to the west of the walled kitchen garden.
Pits	No evidence
Hotwalls/furnaces	None
Heating pipes/boilers etc.	A Thomas Messenger “Quorn” boiler was installed in 1918 to heat the right-hand greenhouse (see above). Heating pipes still remain though the boiler has been removed and the boiler house demolished. (A pit remains). The 1992 listing refers to the boiler house as a “lean-to boiler house with gable stack”.
Backsheds, workrooms, stores	<p>There are extensive back sheds on the north side of the north wall. See EH listing.</p> <p>These are lean-to with 8 windows and 6 doors. One of these might possibly have been a mushroom house as there is evidence of slots in the walls for timbers to support the shelves.</p> <p>The south-west corner has an 19th century L-shaped outbuilding. See EH listing</p>

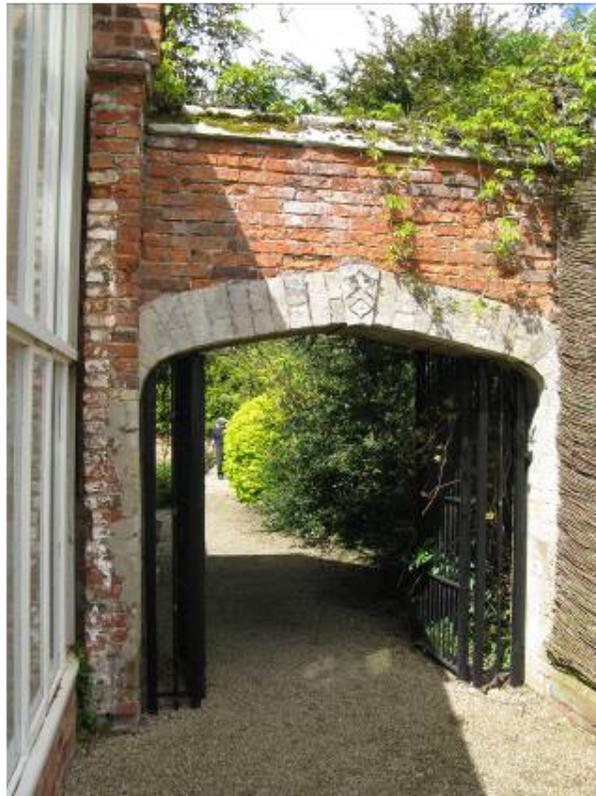
Below: Archway between half-span glasshouses, leading to gardener's cottage
