**Leicestershire and Rutland Gardens Trust
Walled Kitchen Garden Register**

Name of House:	Husbands Bosworth Hall			
Address:	Theddingworth Road (South-east side) Husbands Bosworth LE17 6NL			
Ownership:	Private <input checked="" type="checkbox"/>	Public <input type="checkbox"/>	Institutional <input type="checkbox"/>	Other <input type="checkbox"/>
Grid reference: SP647 843	Landranger Map No: Landranger 140			
Date original WKG created:	There has been a kitchen garden at Bosworth Hall since before 1785. There is a letter from the chaplain to the family in France, which refers to 'the planting of trees round the kitchen garden' and it is dated 20 th February 1785.			
Other key dates in development:	Husbands Bosworth Hall is made up of 2 distinct dwellings, the older part is Tudor in origin and faces SE, the later part was built c1789 and faces NW. The 2 are linked by a Victorian Gothic wing c1870. The renovations at this time included the laying out of the park and a shrubbery. A WKG may have been created as part of this work. There were originally 2 walled gardens. One was on the other side of the road, now the A4304, and is now pastureland although some parts of the walls still ex

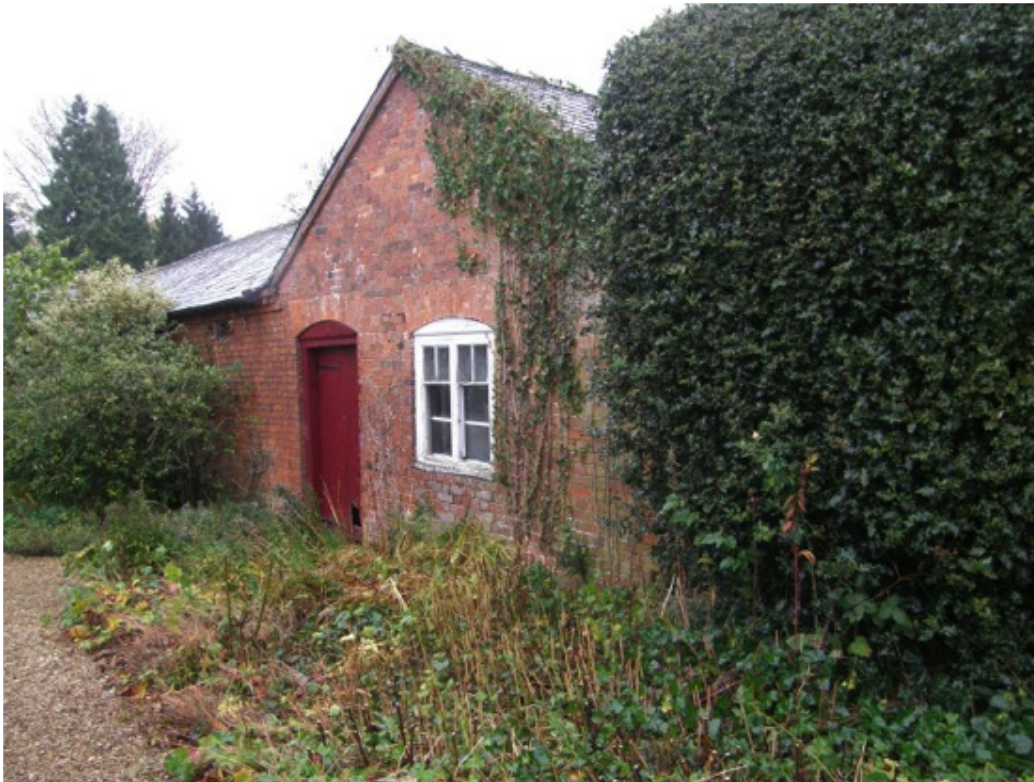
Backshed on the NE side of the WKG now used as a potting shed. Beside this the wall is replaced by a hedge

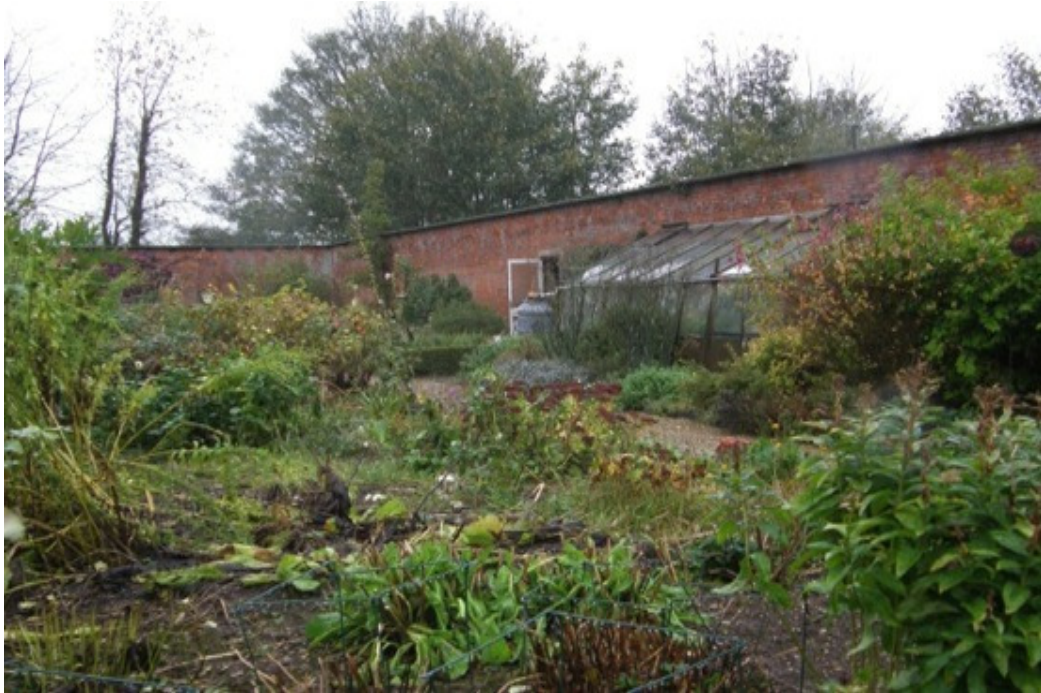
The NE and NW walls meeting in the Northernmost corner. A modern lean-to glasshouse is shown and the door into the backshed housing the pigswill oven

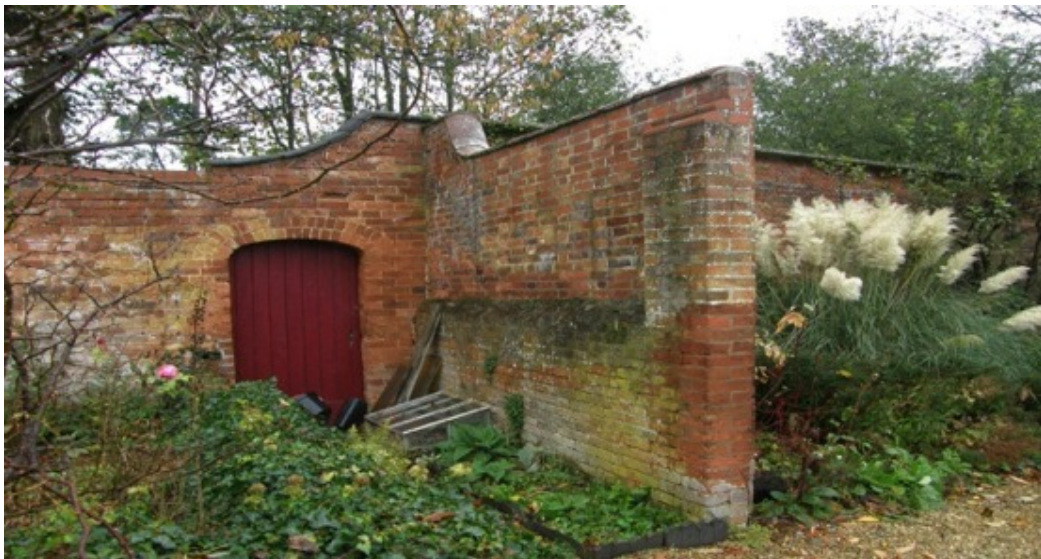
This is the projection from the NW wall that provided protection for the peach house and vinery. The door led to the boiler house situated against the wall on the outside of the garden. The glasshouse would have abutted the door and traces of whitewash can be seen on the back wall.

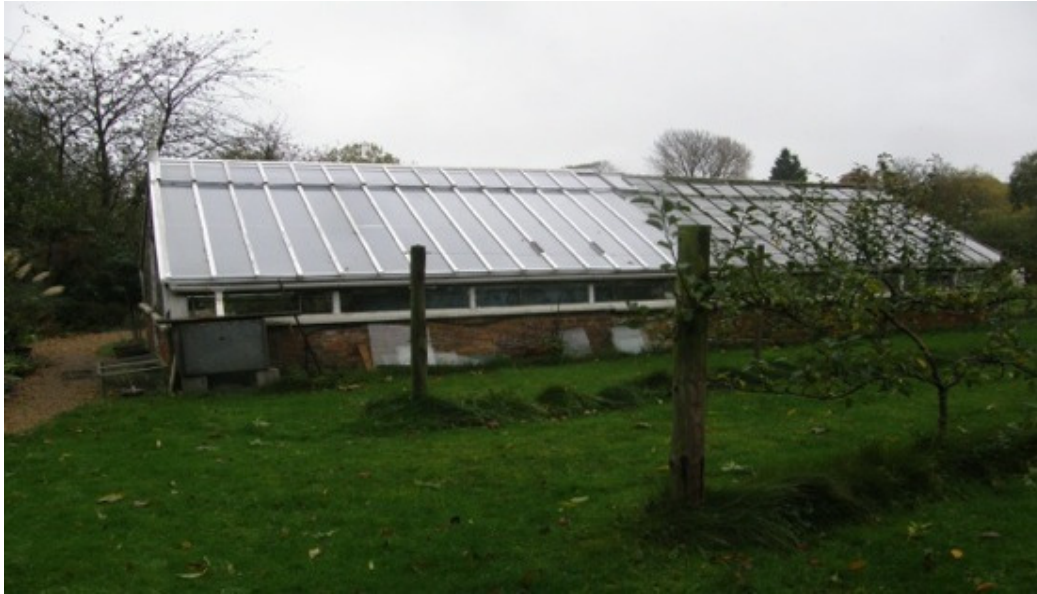
A side view of the original Messenger glasshouse built c.1879. The position of the 2 compartments is indicated by the change in the roof i.e. the replacement roof is at the door end and the original one at the far end.
