Leicestershire & Rutland Gardens Trust

Walled Kitchen Garden Register

Name of House:	Whatton House		
Address:	Kegworth LE67 3EE		
Ownership:	Private		
Grid Reference: SK42 SE5/203		Map No: OS Landranger: No 129	
Official Designations	Historic England listing for Whatton House & Attached Stables Reference: 1359393 (16 January 1989) Grade II 1000968 (1 February 1987) Grade II		
Date original WKG created:	C1802 (<i>Historic England SK4924</i>)		
Other key dates in development:			
1802-3	Exchange of manors was made between Thomas March-Philipps of Garendon Park and Edward Dawson, through which the latter became Lord of Whatton (<i>Nichols, 1804</i>).		
1802-3	Dawson demolished the old house and replaced it with a house built on high ground and set in a landscape park 1.5km to the north-east of Loughborough overlooking the River Soar. The house was built by Leicester architect John Johnston who also designed the County Rooms in Leicester (<i>Historic England, 1987</i>).

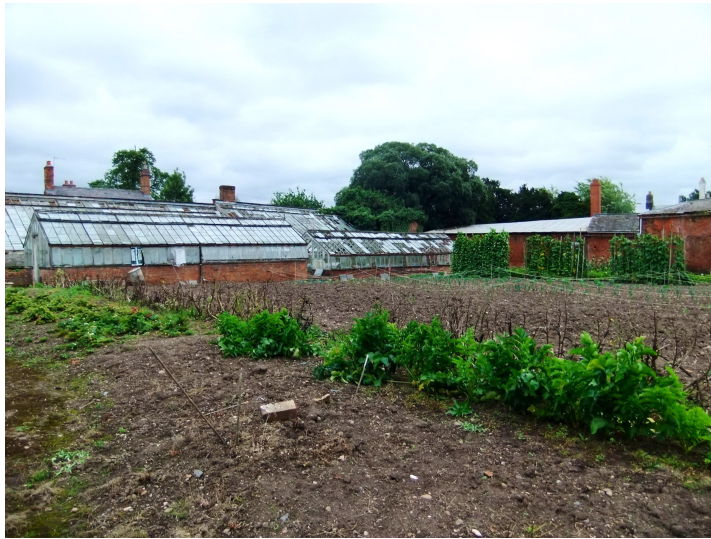
Figure 1: Whatton House Walled Kitchen Garden from the South, showing greenhouses 28th August 2018. (Photo: Sheila Burnage)

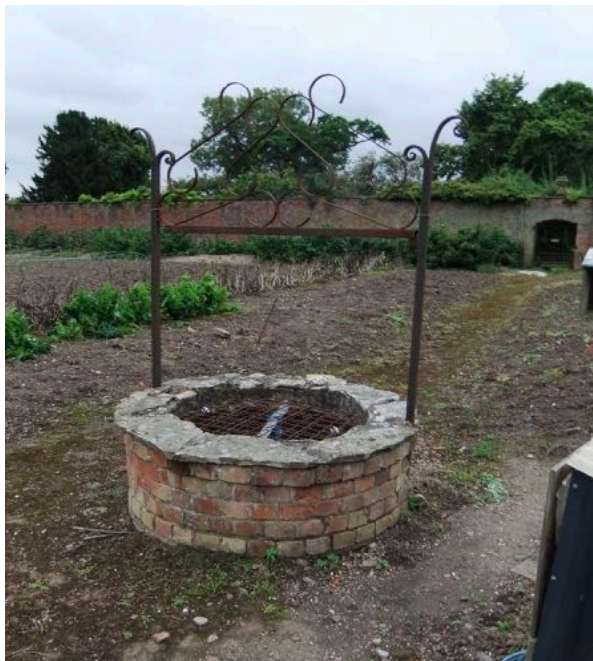
Figure 2: Well with natural spring in centre of Whatton House Walled Kitchen Garden 28th August 2018. (Photo: Sheila Burnage)

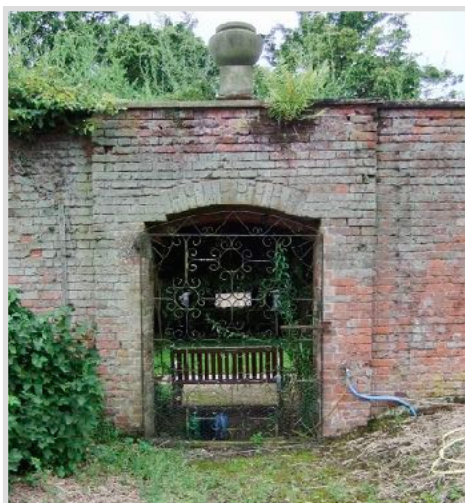
Figure 3: Ornamental wrought iron gate on the south side of Whatton House Walled Kitchen Garden leading into the Broad Walk. 28th August 2018. (Photo: Sheila Burnage)

A decorative wrought iron double gate at the centre of the wall on the south side (<i>Figures 3 & 4</i>) leads out to the Broad Walk, A second decorative wrought iron single gate in the SE corner provides access to the house and swimming pool terrace.
	Two doors lead into the stables/stable yard, one of which has been boarded up.
	A door on the back wall of the Messenger glasshouse leads directly into the back sheds.

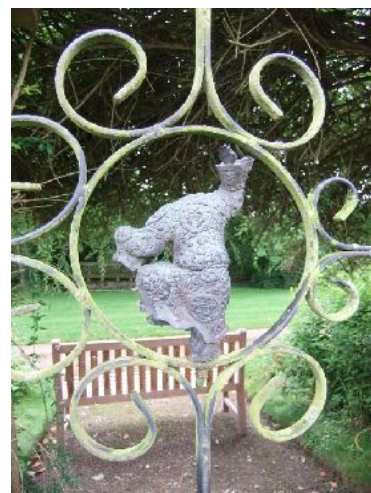
Figure 4: Close up of Chinese decoration on double wrought iron gate, Whatton House Walled Kitchen Garden. 28th August 2018. (Photo: Sheila Burnage)

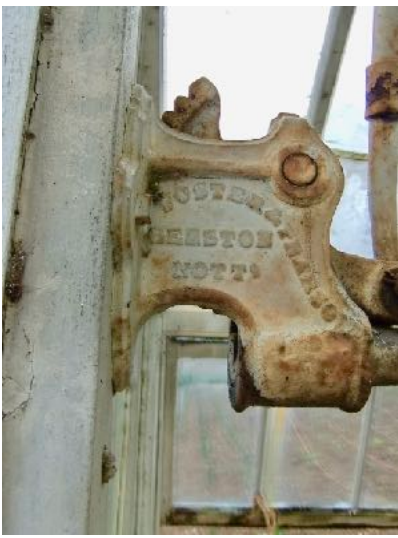
Figure 5: Greenhouse mechanisms showing name of maker, Foster & Pearson, Beeston, Notts, Whatton House Walled Kitchen Garden. 28th August 2018. (Photo: Sheila

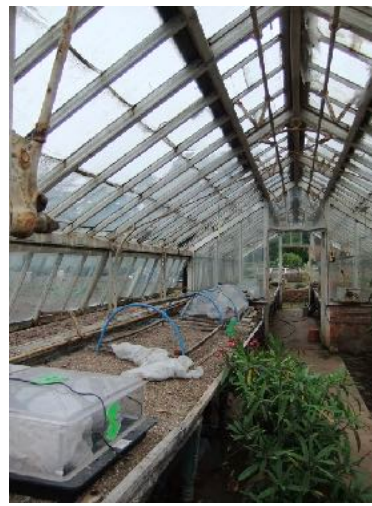
Figure 6: View of one of the Foster & Pearson part sunken double span greenhouses at Whatton House Walled Kitchen Garden. 28th August 2018. (Photo: Sheila Burnage)

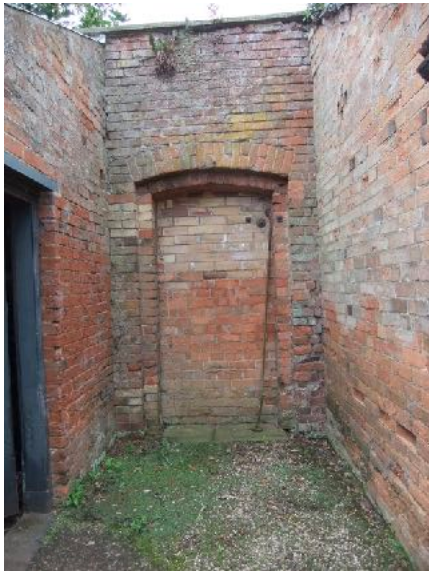
Figure 7: Bricked up original entrance at Whatton House Walled Kitchen Garden 28th August 2018. (Photo: Sheila Burnage).

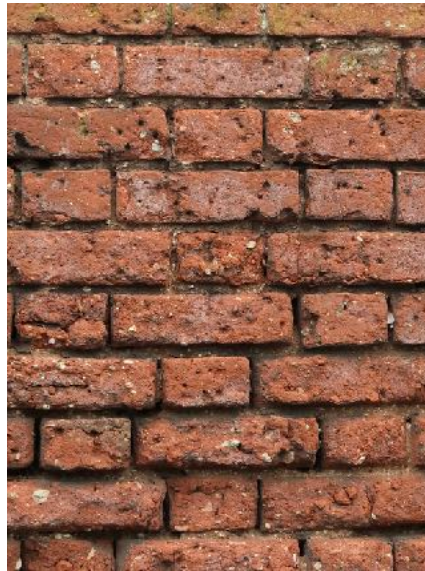
Figure 8: Close up of brick wall at Whatton House Walled Kitchen Garden showing Flemish bond. 28th August 2018. (Photo: Sheila Burnage)

Walls, doors and gates	Red brick walls of mainly 9 x 4 x 2.5" hand made bricks laid in Flemish bond (Figure 9) surround all four sides of the kitchen garden, the east wall following the line of the stables (<i>rough sketch map Figure 14</i>). Flat stone copings top the walls, with decorative urns set at intervals on the south and west walls. There are no buttresses.
	At some stage a hot wall on the north west side, no longer in use, was extended by six courses of factory made bricks. Lean to glass houses were erected against the extended wall. This increased height would have maximised light exposure.
	The frame yard wall was re-built c2007 (oral evidence) as it had become unstable. An attractive curved brick lintel has been inserted at the site of the original entrance to the pleasure grounds.
	There are six entrances to the WKG. The original entrance from the frame yard into the WKG was bricked up at some stage and a new entrance created (<i>Figure 7</i>). We have been unable to establish when this was but it may have been when the hot wall fell out of use in favour of using glasshouses.

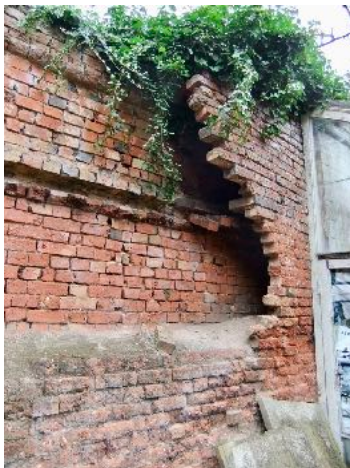
Figure 9: View of part dismantled hot wall, revealing how it was constructed. Whatton House Walled Kitchen Garden north wall. 28th August 2018. (Photo: Sheila Burnage)

The dimensions revealed by the collapsed section in the middle of Whatton's wall follow Miller's recommendation for the first (lowest) and second flues - i.e. 30" and 24" deep, respectively. The space below is sufficient for a primary flue, also of 30". There is not room for a fourth flue above the 24" section which suggests there were just 3 flues with the chimney at opposite end of the wall to the furnace.

A further departure from Miller is the use of a single standard sized brick for all of the construction. The flue "ceilings" are not oversized brick tiles but two 9" bricks butted together, resting, cantilever style, on protruding half bricks (around 6" long). Above them a single row of bricks, bonded into the external and internal walls, provides some additional stability. The underside of these makeshift "tiles" was probably plastered as there is a considerable amount of sooty plaster which has collapsed onto the base of the exposed flue.

The bricks used are stock bricks 9"x2.5"x4.25". They seem to be the same as used in the nearby back-shed and were almost certainly made locally. The front (fruit side) wall is a single brick thick (4.25") and the back wall is 9" thick which follows Miller's advice.

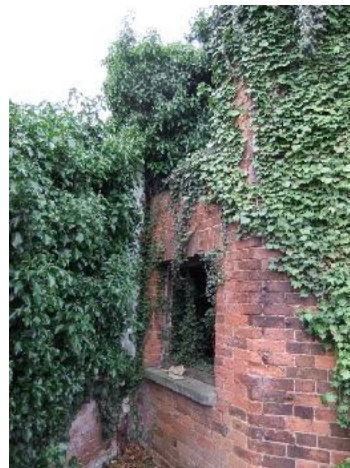
Figure 10: View of the remains of a two story octagonal bothy in the north west corner of Whatton House Walled Kitchen Garden. 28th August 2018. (Photo: Sheila Burnage)
