**Leicestershire and Rutland Gardens Trust
Walled Kitchen Garden Register**

Name of House:	Great Bowden Hall, formerly Bowden Hall			
Address:	Leicester Lane Great Bowden Market Harborough LE16 7HP			
Ownership:	Private ✓	Public	Institutional	Other
Grid reference:	SP732 891	Map No: Explorer 233		
Official Designations	Designation: English Heritage	Reference: 189708	Grade: II	
Date original WKG created:	It is likely that the WKG was created between 1857 and 1886 when the Britannia Inn was converted into Bowden Hall.			
<p>Other key dates in development:</p> <p>Bowden Hall was not built as an original country house. It was a development and an extension of a much earlier building, the Britannia Inn.</p> <p>Early 19^c – The Britannia Inn was built to serve the canal navvies and waterway workers when the Grand Union canal was opened from Foxton to Market Harborough in 1809.</p> <p>1857 – The property was bought by William Harrington Hay when the canal system became less used due to the development of rail and road transport. He subsequently converted the building into Bowden Hall. It is likely that the WKG was part of this development. The property remained in the Hay family for the n

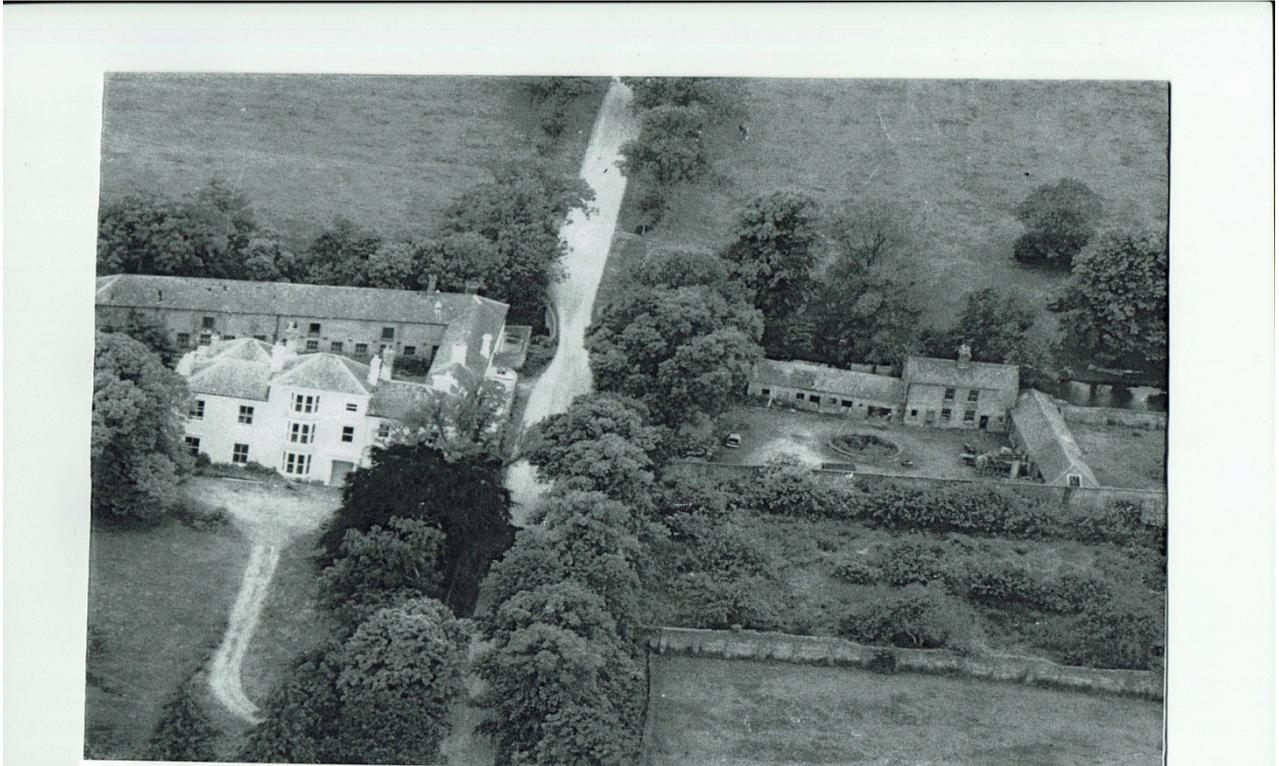
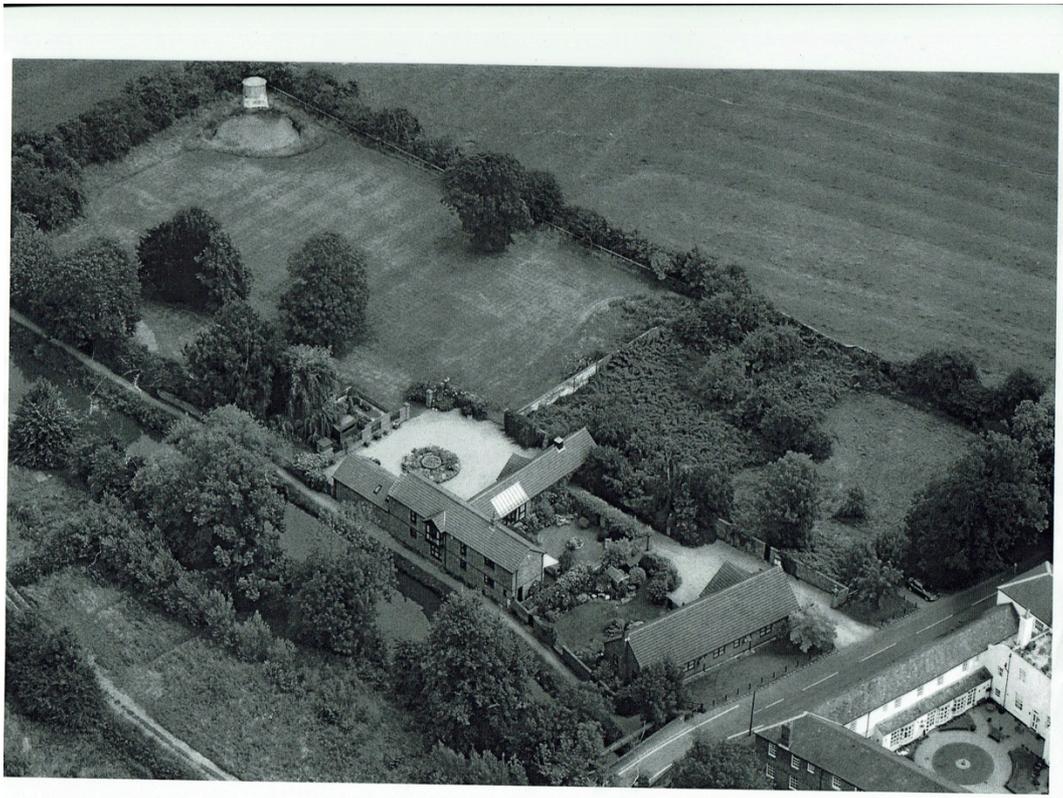
These 2 aerial photos show the WKG in the 1980's when it was derelict and in 2007 when clearing work had started. The lower photo shows the whitewash on the North wall where there was a glasshouse.

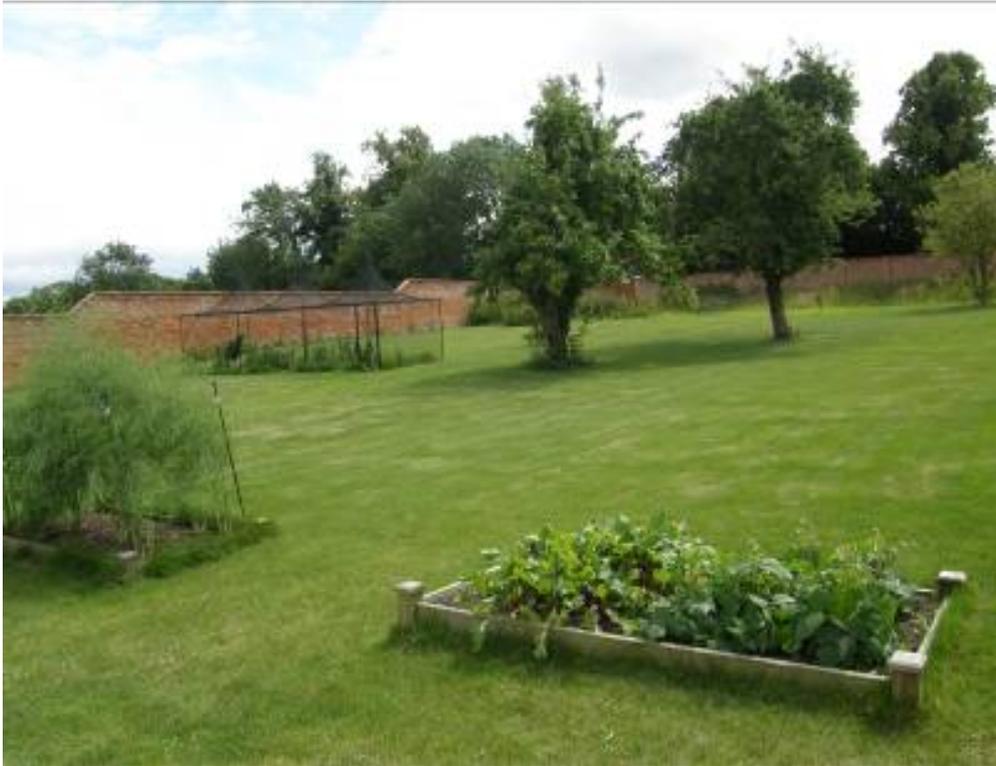
This photo shows the renovated East and South walls and the planting at the time of our visit

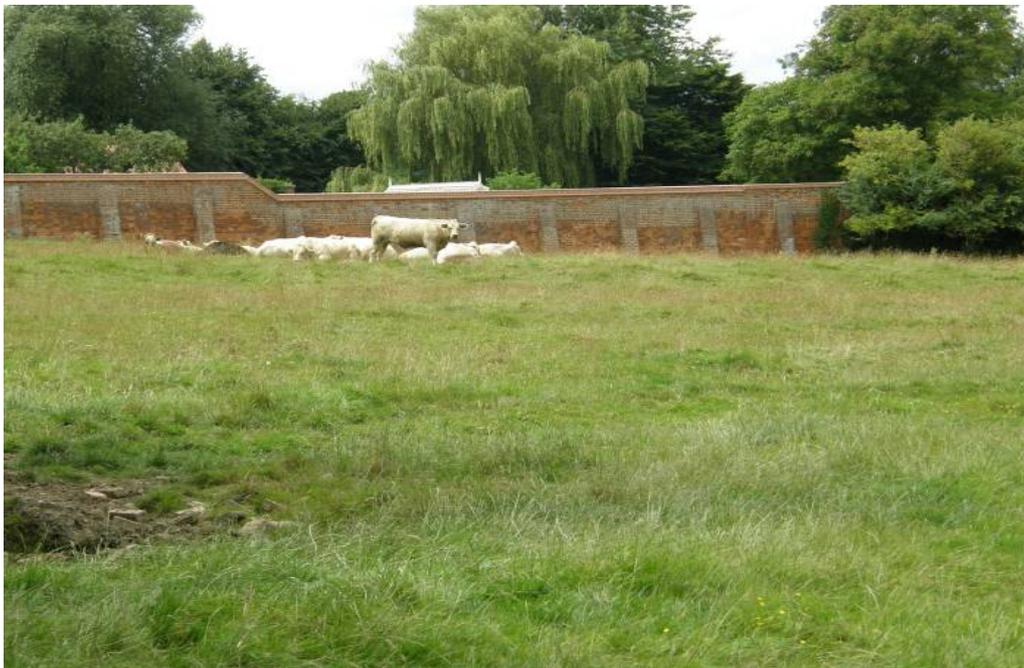
This is taken from the outside of the East wall and shows the buttresses. It also shows the extent of the renovation of the wall.

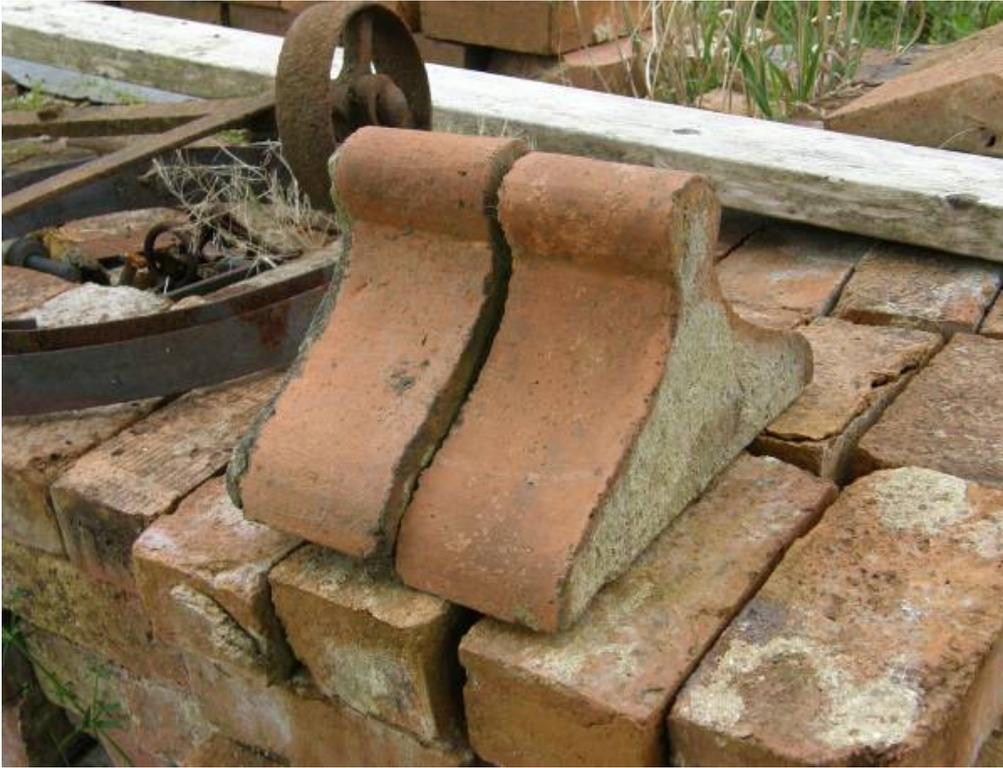
2 examples of the decorative coping that is thought to have been used on the original South wall

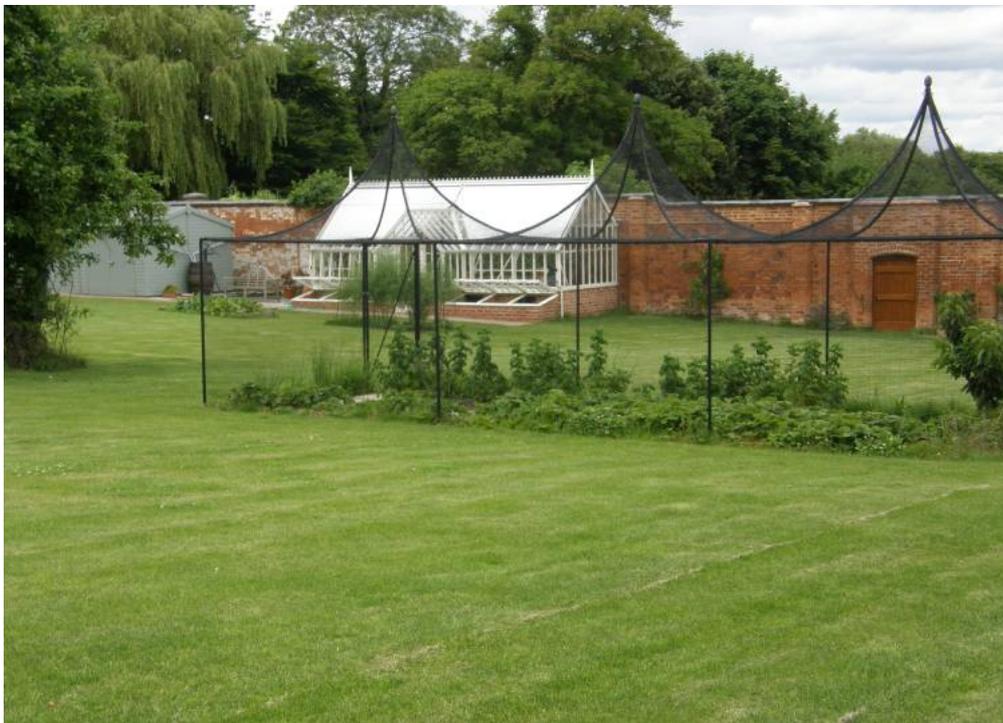
The new glasshouse and frames sited along the North wall. Also shown are the new shed, the new fruit cage, the whitewash on the wall from the original glasshouse and the restored doorway near the site of the pump
