Leicestershire and Rutland Gardens Trust Walled Kitchen Garden Register

Name of House:	Wistow Hall						
Address:	Kibworth Road						
	Wistow						
	LE8 0QF						
Ownership:	Private x	Public		Institutiona		Other	
Grid reference: SP 639958 Map No: Landranger 140							
Date original	Circa 1820						
WKG created:							
Other key dates	Wistow Manor was bought by the Halfords in 1603 which is the						
in development:	approximate date of the H-plan house. In 1814 the house						
	passed to Sir Henry Halford, Royal Physician. He carried out						
	extensive improvements to the house and the estate and this						
	may have included the creation of the walled garden.						
	The WKG is recorded on an estate map c.1830-40 but no vinery						
	is shown. The first record we have seen of the vinery is in the 1 st						
	edition of the OS map published in 1886. There has been little						
	structural change since then although the area is now used as a						
	garden centre.						
Size and brief	1.300 acres. O	rientatio	on: North	south.

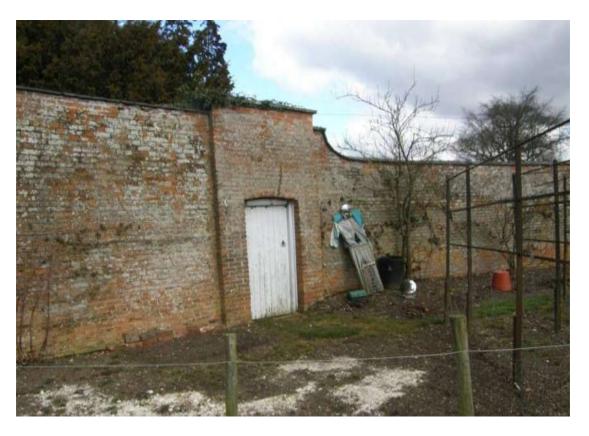
The disused door in the North East side of the WKG showing the difference in height between the curved North wall and the straight side wall

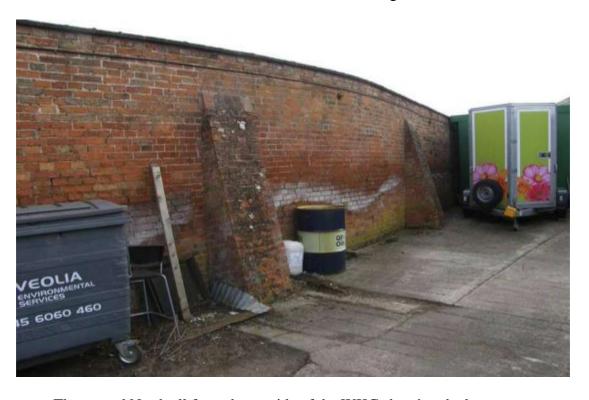
The curved North all from the outside of the WKG showing the buttresses

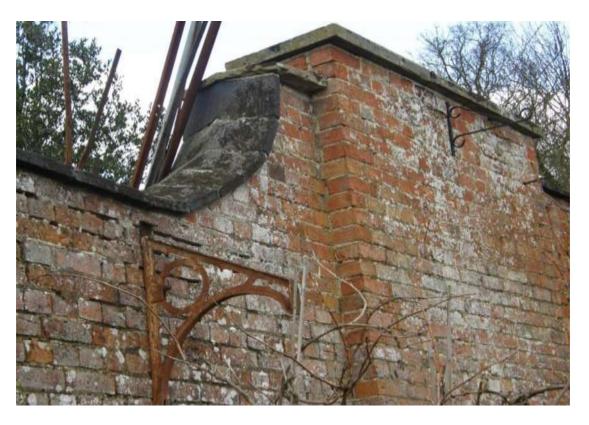
The wall bracket in the foreground is one of a series equally spaced along the West wall and the western side of the North wall. These were used to support a shelter for the plants from the intense heat of the morning sun after a frosty night

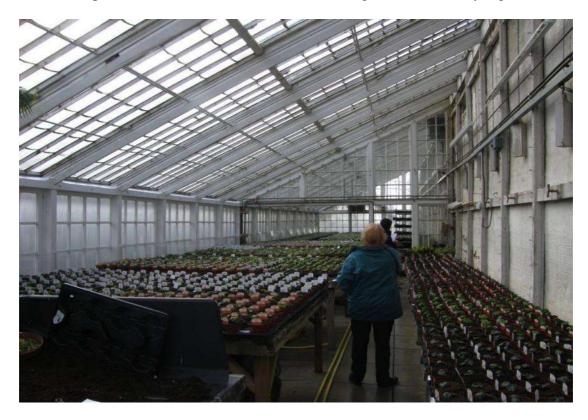
The interior of the vinery showing the central partition and weights along the back wall that are part of the original mechanism to open areas of the roof

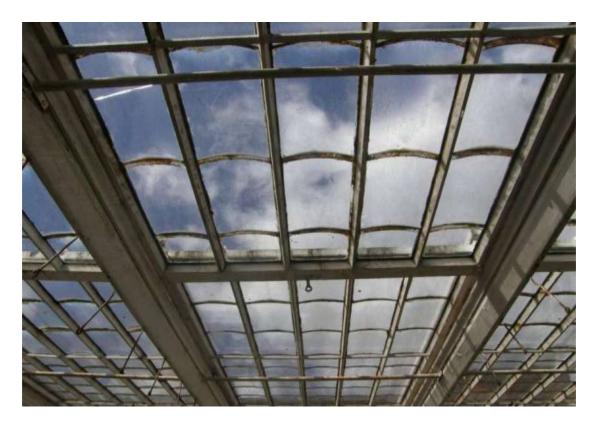
The roof of the vinery showing the lower edges of each pane of glass designed to provide better drainage

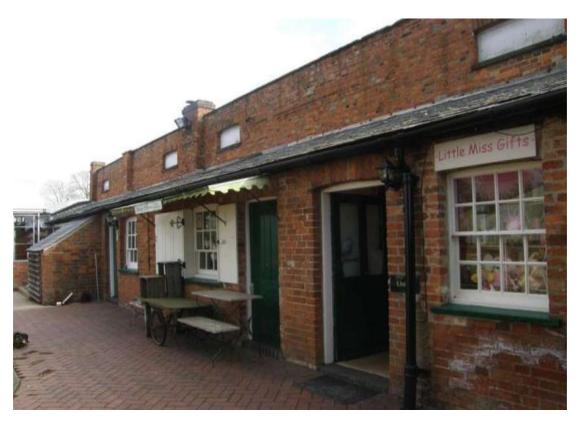
Some of the backsheds, now shops, that are behind the vinery. The lower lean-to at the end is the boiler house
