**Leicestershire and Rutland Gardens Trust
Walled Kitchen Garden Register**

Name of House:	Osbaston Hall			
Address:	Osbaston Leicestershire CV13 0BW			
Ownership:	Private			
Grid reference: SK42375 04512		Map No: OS Explorer No 233 – Leicester & Hinckley		
Official Designations	Designation: Historic England 7th November 1966	Reference: ID: 1361278	Grade: II*	
Date original WKG created:	Unknown but evidence of existence shown on OS 6" Map, 1885			
Other key dates in development:				
	<ul style="list-style-type: none"> • The original manor house dates from late 16th or early 17th century. • Mid 17th Century - manor acquired by the Wrightson Family and then by the Mundy family when Philippa Wrightson, heiress, married Frances Mundy. • 1750 - manor house rebuilt by Wrightson Mundy (grandson of Philippa Wrightson), High Sheriff of Derbyshire and MP for Leicester in 1737). There is a discrepancy regarding dates: the Historic England listing gives 1720. However, the 1978 sales catalogue gives the date as 1750. • 1766 - estate sold by Noel Clarke Mundy. • 1787 - The Hall, together with the Lordship of the Manor, was purchased by Josias Cockshutt-Twistleton. • 1828 - estate acquired by Th

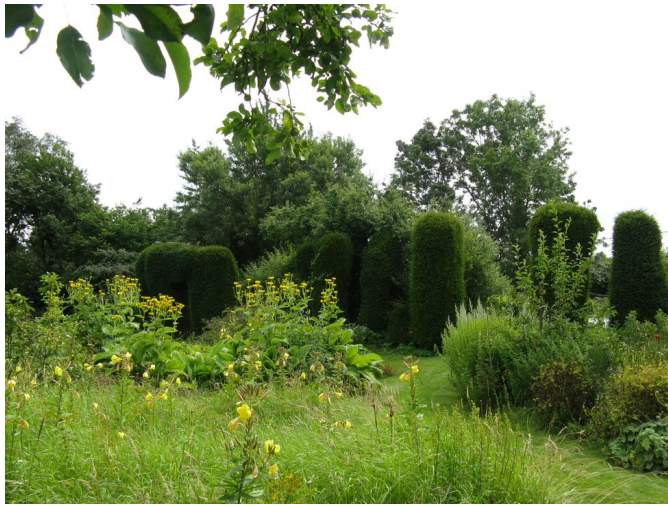
Figure 1: General View showing planting, Osbaston Hall Walled Kitchen Garden, 2012
(Photo: Sue Blaxland)

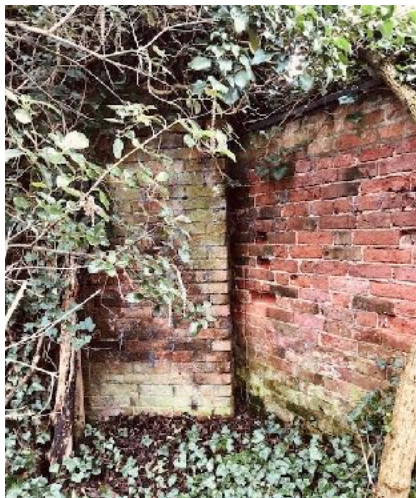
Figure 2: Corner of east wall, Osbaston Hall Walled Kitchen Garden, April 2023. (Photo: Sheila Burnage)

Size and brief description	
	<p>The site is an elongated rectangle lying to the south-east of the Hall, parallel with the village street. It is oriented north-west to south-east and is narrower at the west, broadening to the east. The site is level. The soil, described in the sale particulars of 1967, is a rich light loam.</p> <p>The sales catalogue states that the estimated acreage is 1.09 acres. (<i>Ref: Sales Catalogue, Osborne & Partners and Shakespear, McTurk & Graham, May 1967</i>)</p>
<p>Current Use: It remains a kitchen garden which is still partially cultivated. It contains fruit trees, soft fruit, vegetables and perennial plants (<i>Ref: site visit 2023</i>).</p>	
Features: further information and current condition:	
Walls, doors, gates	<p>The garden is surrounded by red brick walls, with heights varying from 6ft to 15ft.</p> <p>The walls are made up of a mixture of machine and hand made bricks, with stone and cement copings. The oldest bricks possibly the same date as the house. These measure: 9 1/4" x 2 3/4".</p> <p>The brick bond varies, but in the oldest part, are one header followed by two stretchers. (<i>Ref: Figure 2</i>)</p> <p>Part of the wall was re-built in the 1960's by Mrs Guinness.</p> <p>There are five entrances to the WKG - four wooden and one composite. (<i>Ref: Figure 3</i>)</p> <p>(<i>Ref: Site visit 2023</i>)</p>

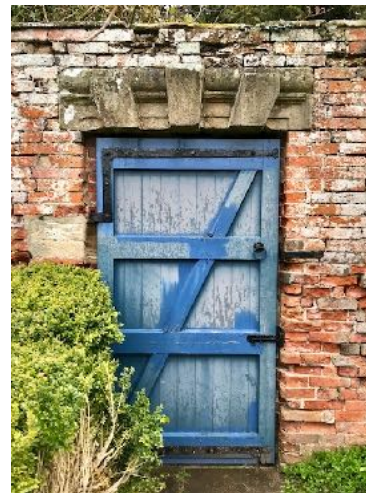
Figure 3: Osbaston Hall Walled Kitchen Garden, view of north gate, April 2023.
(Photo: Sheila Burnage)

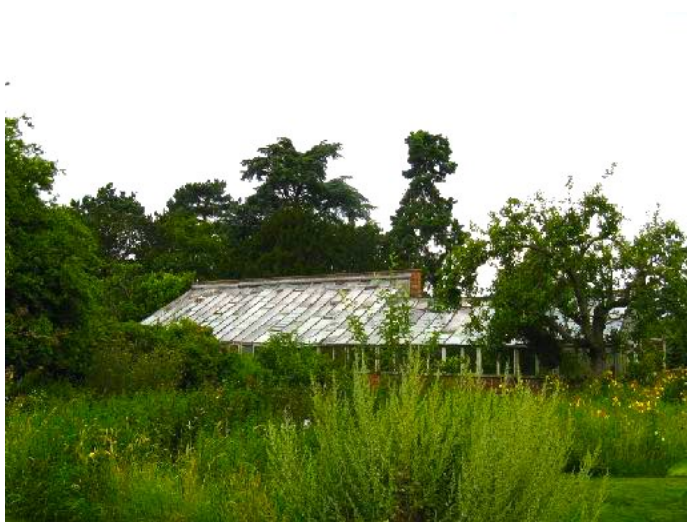
Glasshouses	<p>Lean-to Vinery and Peach House:</p> <p>The 1967 sales catalogue describes "a lean-to vinery and peach house 66 ft long containing 7 productive vines, 2 peaches and nectarine with heating installed and adjoining stoke hole, also an apple room."</p> <p>The 1978 sales catalogue describes one heated span greenhouse 30 ft long; one lean-to greenhouse 40 ft long.</p> <p>A photograph taken on a site visit in 2012 shows lean-to and 3/4-span greenhouses, so there are discrepancies in the catalogues and it is correct to state that, against the south wall, there were originally three adjoining glasshouses: 2 lean-to houses and one 3/4 span house. (<i>Ref: Figure 4</i>)</p>

Figure 4: Lean to vinery and peach house at Osbaston Hall Walled Kitchen Garden, showing lean to and three-quarter span houses, 2012. (Photo: Sue Blaxland)

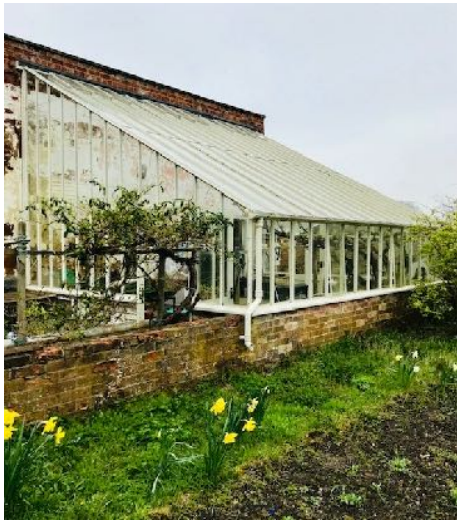
Glasshouses, continued	<p>One lean-to has recently been restored with new ironwork and glazing on the existing brick base. (Ref: Figure 5)</p> <p>The other lean-to base has been retained and there are plans to rebuild it. (Ref: Figure 6)</p> <p>There are some training wires in the greenhouse.</p> <p>The 3/4 span has been removed but retains its pipework and base. There is evidence of white paint on the walls confirming the position of the former glasshouse. (Ref: Figure 7)</p> <p>There are also two small modern span houses in the northeast of the garden.</p> <p>To the southeast of the greenhouse and surrounded by an old yew hedge is a sunken span glasshouse, measuring approximately 13ft x 32ft, built in two sections. It is built 4ft below ground level and is entered via steps down from ground level. It has brick walls up to ground level, glass sides from ground level and a glass roof. The stages were made of slates, some of which still remain. (Ref: Figures 8 & 9)</p>

Figure 5: Restored lean-to house at Osbaston Hall Walled Kitchen Garden. April 2023. (Photo Sheila Burnage)

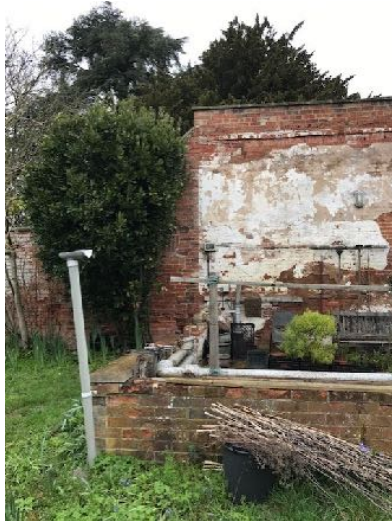
Figure 7: Pipe Work in unrestored greenhouse at Osbaston Hall Walled Kitchen Garden. April 2023. (Photo: Sheila Burnage)

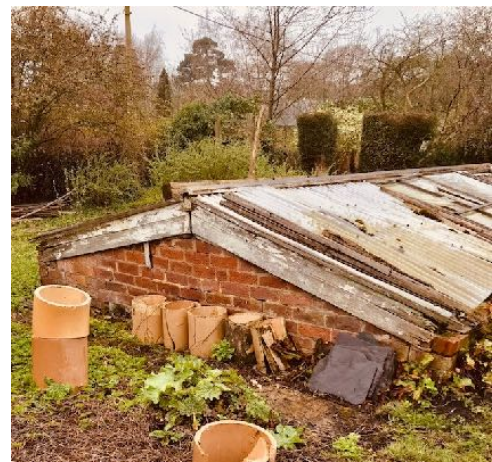
Figure 8: Sunken span greenhouse (Melon House) in Osbaston Hall Walled Kitchen Garden. April 2023. (Photo: Sheila Burnage)

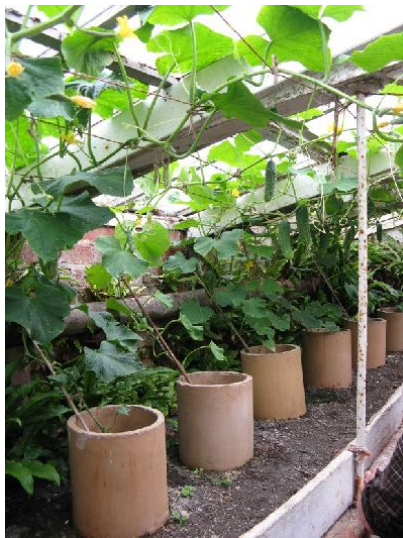
Figure 9: Interior of sunken Span house in Walled Kitchen Garden at Osbaston Hall. 2012. (Photo: Sue Blaxland)

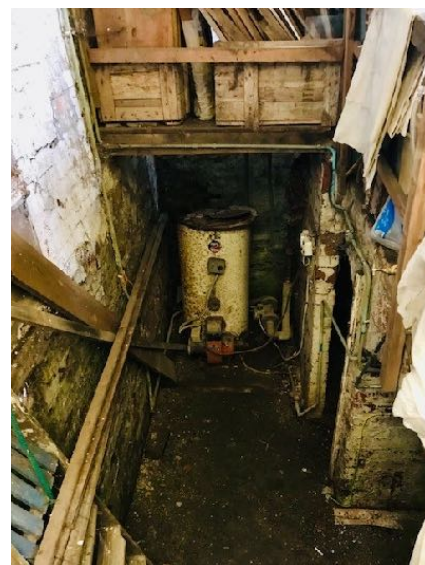
Figure 10: Henry Wilson boiler in potting shed in Osbaston Hall Walled Kitchen Garden, April 2023. (Photo: Sheila Burnage)

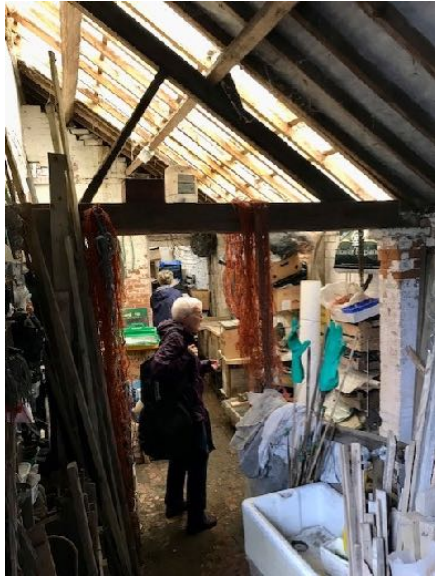
Backsheds, workrooms, stores	There is a large backshed behind the North wall of the lean-to greenhouse. The 1967 sales catalogue describes it as 'an apple room'. The storage racks are still in place. It is still used as a storage area for produce from the garden. (Ref: Figure 11)
Gardener's house, cottages, bothies	There is no evidence of any of these.
Wells, ponds, tanks, towers	There are two water pumps, one outside the lean-to glasshouse with an extensive underground rainwater fed tank. The other water pump is inside one of the lean-to glasshouses. (Ref: Figure 14)
Planting	<p>Current general planting of vegetables, fruit and ornamental plants.</p> <p>There is a grapevine in the lean-to house which, unusually, is planted inside the house in a contained brick edged bed. Its roots are fed through the wall to the outside. This may be one of the original seven grapevines. (Ref: Figures 12 & 13)</p> <p>There are two fairly recent kiwi fruit plants in the former 3/4 span house. (Site visit 2023)</p> <p>Other planting includes a Doyenne d'Ete pear, nectarines and peaches, damsons and greengages, apples and cherries. There are some existing very mature fruit trees, and mature yew trees and box hedging. The Yews have now been hard-pruned. Prior to this they had been clipped to form hedges and archways to divide the garden into separate "compartments" (Site visit 2023).</p> <p>The 1967 sales catalogue describes the kitchen garden as 'still partly cultivated with a rich, light loam and having raspberry beds, asparagus beds. The kitchen gardens contain 40 apple, pear and plum trees and a lean-to vinery and peach house, 66ft long, containing 7 productive vines, 2 peach and nectarine.'</p>

Figure 11. View of potting shed at Osbaston Hall Walled Kitchen Garden. April 2023. (Photo: Sheila Burnage)

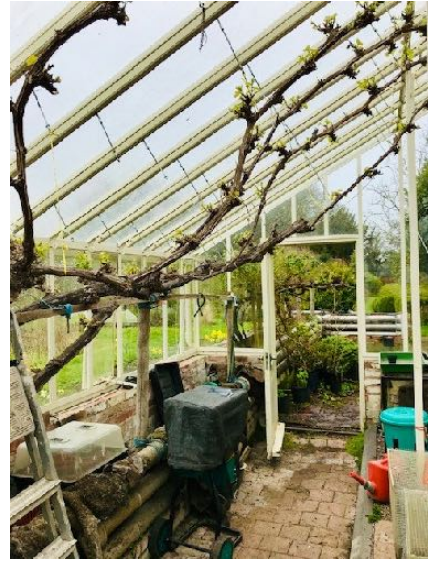
Figure 12: Restored Greenhouse interior showing vines at Osbaston Hall Walled Kitchen Garden. April 2023. (Photo: Sheila Burnage)

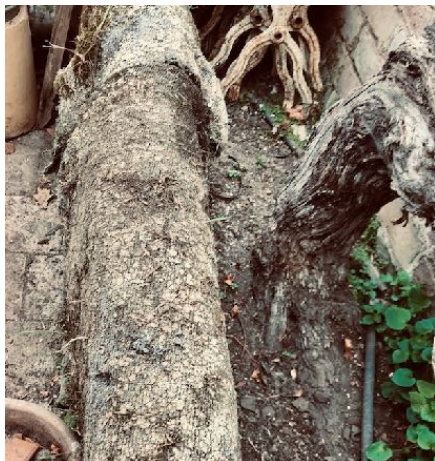
Figure 13: Vines in renovated greenhouse at Osbaston Hall Walled Kitchen Garden. April 2023. (Photo: Sheila Burnage)

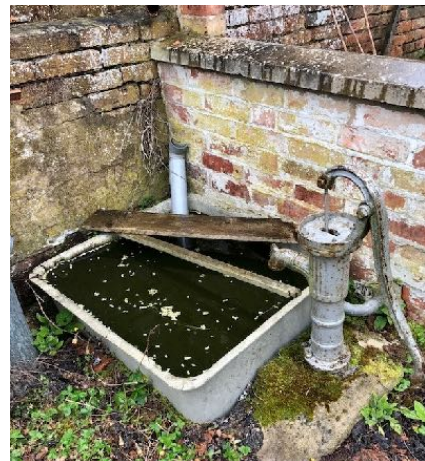
Figure 14: Water pump in unrestored Greenhouse at Osbaston Hall Walled Kitchen Garden. April 2023. (Sheila Burnage)
