**Leicestershire and Rutland Gardens Trust**  
**Walled Kitchen Garden Register**

| <b>Name of House:</b> | East Norton Hall | | | |
| <b>Date original WKG created:</b> | Post 1871 | | | |

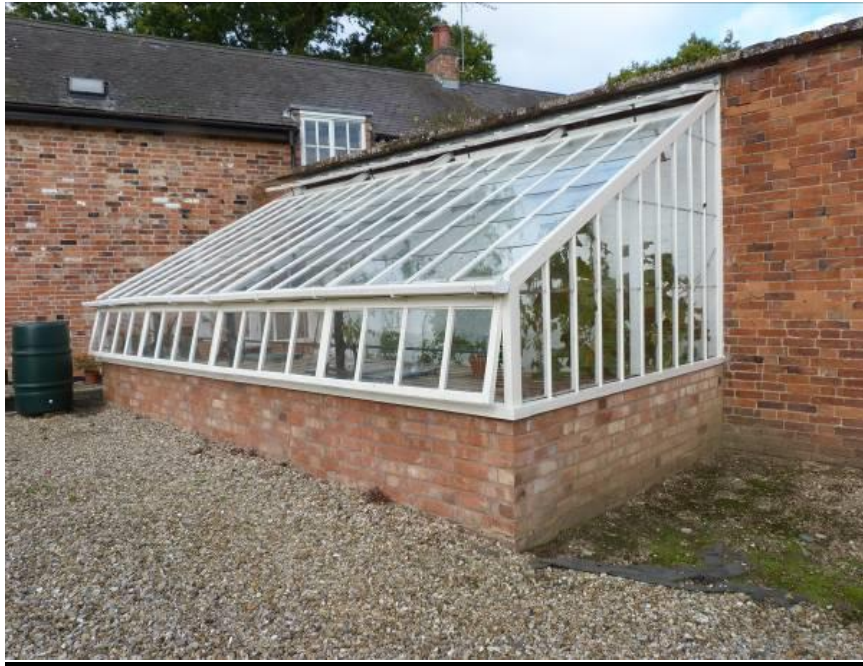
1927/8 Messenger greenhouse in N/W corner

| <b>Glasshouses</b> | <p>We found no evidence of original greenhouses.</p> <p>A Messenger greenhouse built between 1927 and 1928 survives sited next to the north wall and built on the instructions of Miss Heycock, sister of the owner at the time. Miss Heycock wrote to Messenger between November 1927 and May 1928 negotiating the price and ordering the greenhouse and its construction. See appendix.</p> <p>In brief Miss Heycock specified: ‘lean to’ and <math>\frac{3}{4}</math> span - to be built by a wall’. She eventually accepted the size at: ‘20ft by 10ft at a cost of £65-0-0’. Concern for the high price led to the owner not requiring any ‘wood staging for the flowers’.</p> <p>The colour scheme chosen by the owner for the commissioned greenhouse was as follows: ‘I should like all the woodwork inside and out to be white or pale cream. The ironwork <u>inside</u> to be a <u>light</u> blue and the outside ironwork can be the colour it is at present’.</p> <p>The greenhouse has been faithfully restored and painted white by the present owners and the original ventilation system installed by Messenger is still in use.</p> |

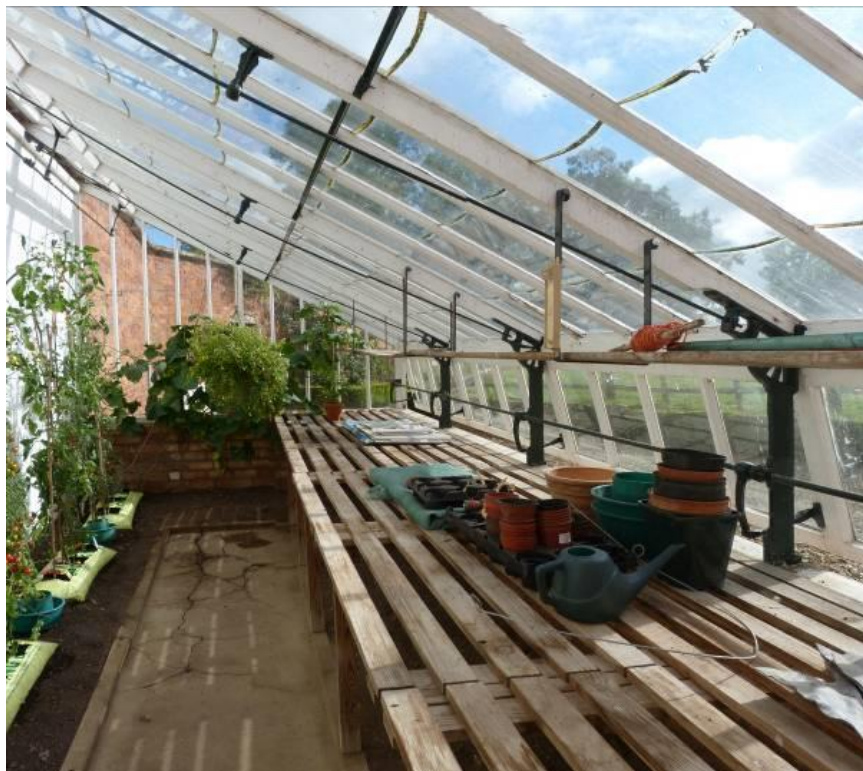
Interior of Messenger greenhouse showing parts of the original ventilation system

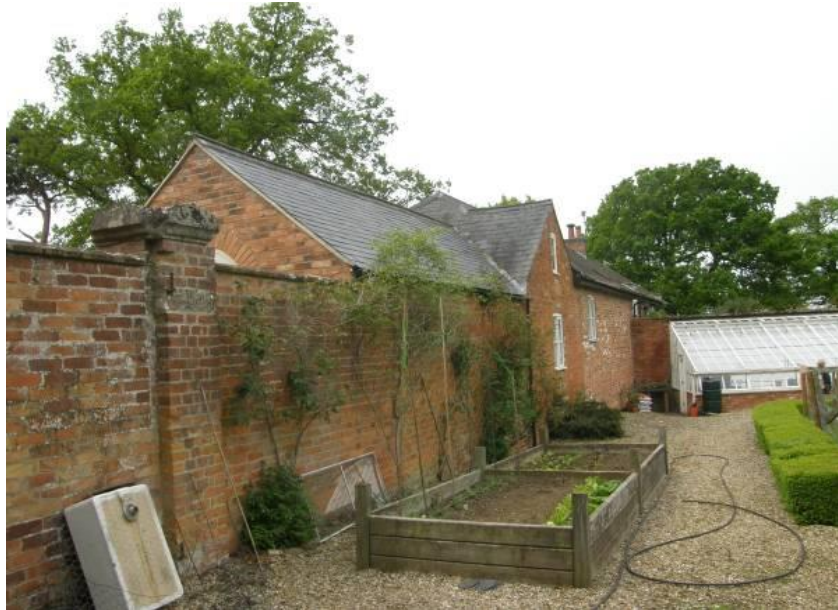
View of west side of walled garden showing raised beds on the foundations of original cold frames and greenhouse. The bricked up wall into the old farmyard can be seen on the left.

| <b>Frames</b> | Today there are two raised beds located between the disused gateway and the greenhouse. These were built on the foundations of six cold frames - still visible. |

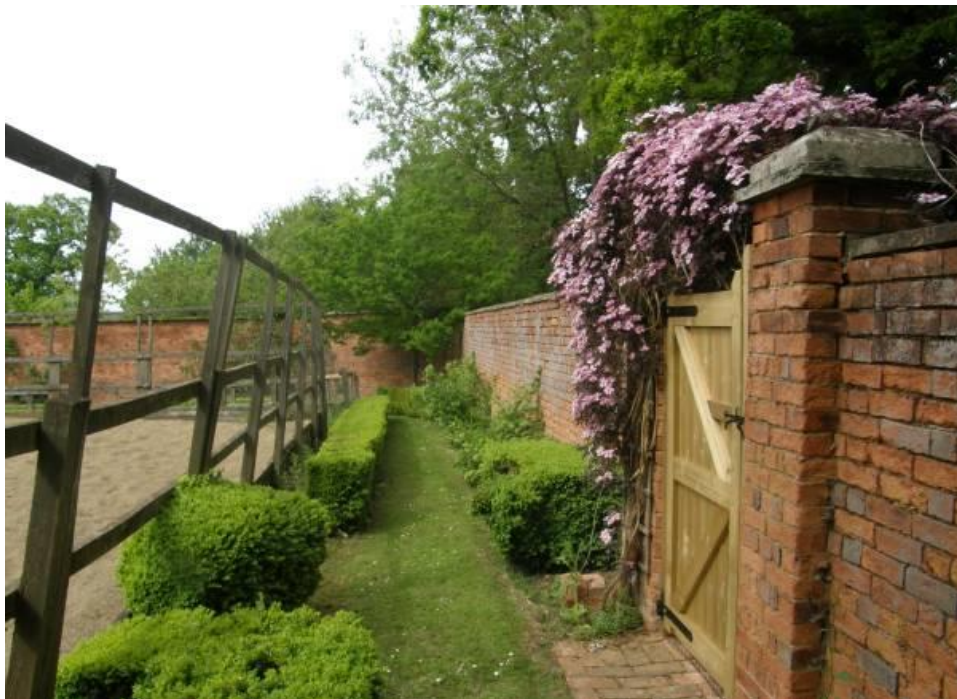
East wall with wooden gate showing old box hedge

| <b>Walls, doors, gates</b> | <p>Today the garden perimeter is composed of the walls of yard buildings and stables to the west; red brick Sussex Bond walls to north and east and a holly hedge to the south. The wall height varies from c. 15 feet in the north west corner down to approximately 7 feet 10 inches in the south west corner.</p> <p>There are four entries to the garden: one from the stable yard; one now bricked up from the north yard; wooden gates in the north and east walls; and steps at the end of the holly hedge – which possibly once extended across the south end.</p> |

| <b>Planting</b> | <p>Earlier planting is not shown in the 1886 <u>O/S Map</u> and does not survive however there is a peripheral path, an old box hedge remaining on three sides of the grassed area, and currently beds for vegetables and soft fruit on the north and east sides.</p> | |

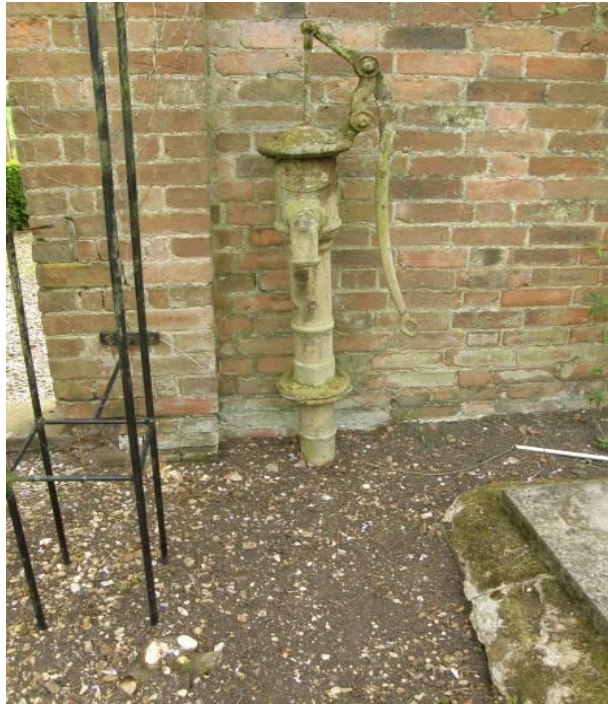
Pump outside wooden gate in  
north wall over old soft water tank

| <b>Wells, ponds, tanks, towers</b> | <p>The 1886 <u>O/S Map</u> shows a well to the north west (of which evidence survives today) and a pump just outside the north wall (still extant) and the current owner mentioned other disused water tanks within the grounds of the hall.</p> | |

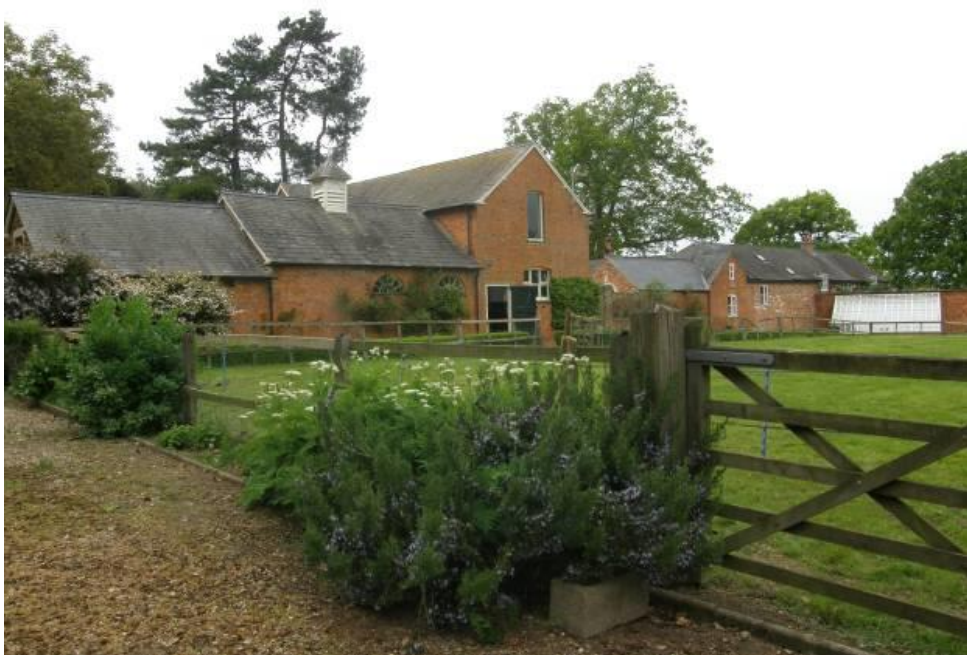
View across the garden towards the west side  
Shows the main stable block with hayloft and other stables on the left. The gardener's  
cottage is to the right beside the greenhouse

| <b>Backsheds, workrooms, stores</b> | <p>We have not ascertained the original functions of all the yard buildings, but the stable yard is still in use with all the facilities of a late Victorian establishment – somewhat modernised.</p> | |
| <b>Gardener's house, cottages, bothies</b> | <p>The gardener's cottage in the north yard was extended in the late 1980s and subsequently all the livestock housing and other buildings in the yard were incorporated in a new residence. Three original windows overlook the kitchen garden.</p> | |
